## Test Report

Report No : L18947 Amd1

**Description**: 1500X200 MOD Secure Surface Luminaire

Test Specification : Environmental design guide adult medium secure services

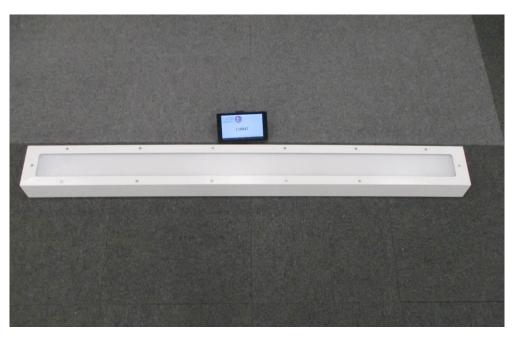
Figure 1. Product Image

Product Description	1500X200 MOD Secure Surface Luminaire
Model No.	DIL-0385-0001
Number of Samples	One
Condition on Receipt	Good
Nominal Dimensions	L1158mm x W190mm x H75mm
Product Supply Requirement	220-240V ~ 50/60Hz
Lamp Type and Power	LED Module

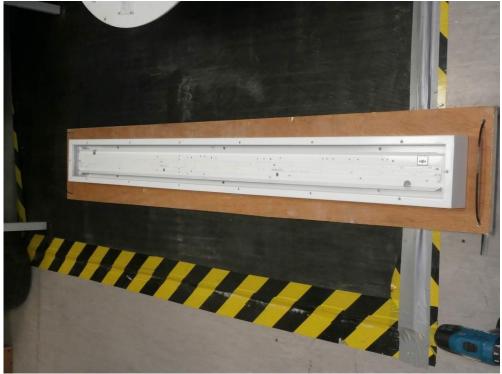
Figure 2. Test Setup

The product was mounted as per instructions and attacked by the mean of 36X36X100 mm hardwood shaft (density 660kg/m3) chamfered at one end to replicate the jagged edge/arises/etc of a vandalised component, to be planed and all arises rounded.

The product was mounted as per instructions and attacked by the means of 1.2 kg rubber mallet (75 mm).

The product was mounted as per instructions and attacked by appropriate tools and equipment or items that a patient may be able to obtain or have access to. (For example, a metal teaspoon, zip components, metal spring from hi-fi headsets, etc).

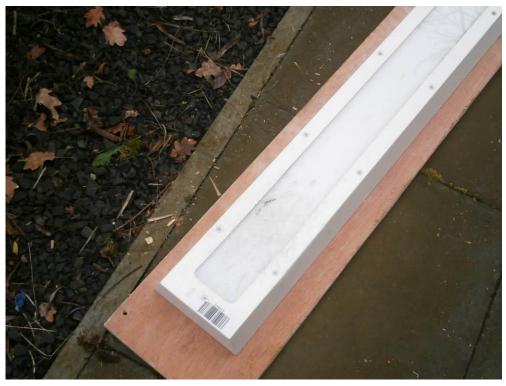
Figure 3. Product Image after the test

The sample was deemed to comply with the requirements because, after the test, there were no visible damages to the Luminaire and no live parts were accessible.

The sample was deemed to comply with the requirements because, after this test, there were no visible damages to the Luminaire and no live parts were accessible.

The sample was deemed to comply with the requirements because, after this test, there were no visible damages to the Luminaire, no sharp edges exposed, and no live parts accessible.
